# Army Lodging Wellness Recommendation

## Final Submittal - USMA West Point

May 21, 2004

## USMA West Point

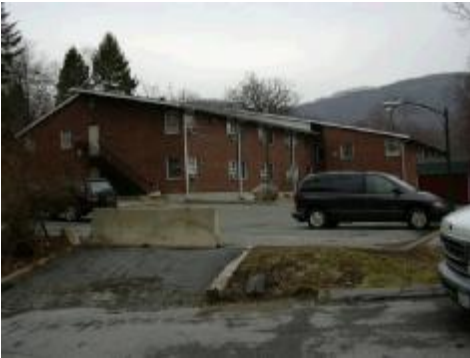
### ***Building 0785***

Building 785, constructed in 1973, is a two-story brick structure housing 24 existing extended stay rooms and 11 family suites.. This building is in poor condition and does not provide appropriate support spaces. The cost to make condition assessment improvements will exceed 50% of the replacement cost.

Our recommendation is to remove building 785 from the Lodging inventory, allowing the installation to determine an alternate use for this facility. This facility will be removed from the USMA West Point Wellness Solution and Lodging Master Plan.

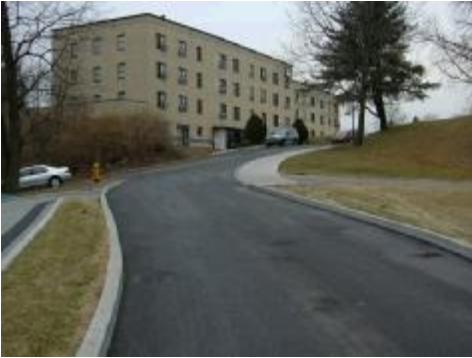
### ***Building 2113***

Building 2113, constructed in 1948, is a historical four-story brick structure housing 31 family suites and 3 single rooms. This facility is located outside of the gated area of the main campus. Although this facility was renovated within the last 5 years, the major building systems need replacement and the facility does not meet Lodging standards and cannot be reconfigured without significant reconstruction. Although the cost to make condition assessment improvements is just over 50% of the replacement cost, it is our recommendation to remove this facility from Lodging inventory due to the age of the building.

It should be noted that this structure may be historic and some Army Lodging functional requirements indicated in the report would require clearance from SHPO or through Army Alternate Procedures: therefore, some of the requirements may need modification, in which case the prices for implementation may vary from the cost models applied.

Our recommendation is to remove building 2113 from the Lodging inventory, allowing the installation to determine an alternate use for this facility. This facility will be removed from the USMA West Point Wellness Solution and Lodging Master Plan.
